FRICTION AND WEAR IN COATED SPECIMENS

B. R. Livesay

Engineering Experiment Station

August 1982

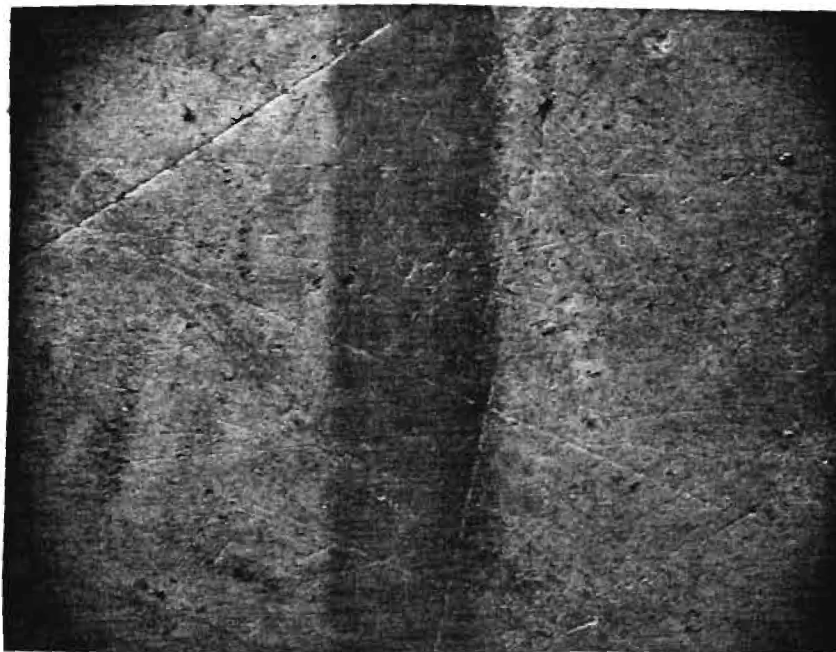
Figure 27. SEM Micrograph of Wear Scar. X2000 Sample 6,
Track 2 (See Table 1)

SEM micrographs of some wear tracks are shown in Figures 16-28. The most severe wear is seen on the uncoated specimen (sample 2). Tracks 1 and 2 were abraded with the sapphire stylus. It appears that the material on this uncoated specimen is redistributed over the surface of the wear track. It is also clearly seen that a profilometer trace made at one point along a wear track will be different from that, in detail, at any other point. Wear in the coated specimens apparently initiates at weak points in the surface and grows from there.
